**Flood Control Project Maintenance
Levee Inspections**

2010 Channel Summary Report

Merced Streams Group

**Flood Control Project Maintenance
Channel Inspections**

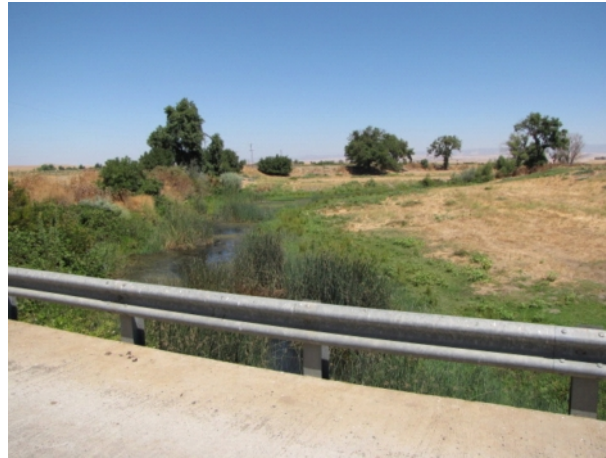
Levee Mile Report Line	1
Start Levee Mile	0.00
End Levee Mile	0.00
Location	
Category	Channels
Item	Vegetation & Obstructions
Bear Creek upstream of Bonner Rd.	
phillips_c_20100913_120.jpg

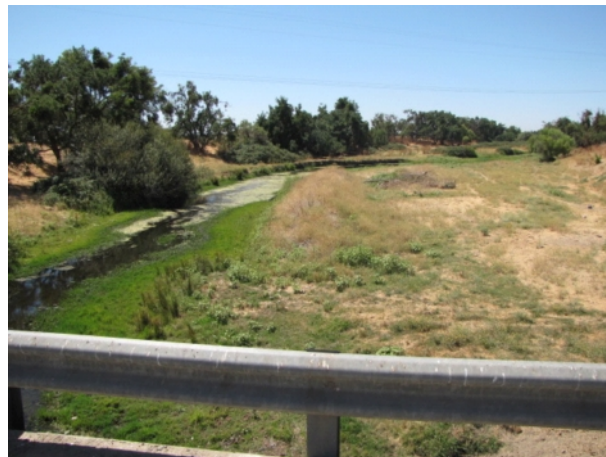
Levee Mile Report Line	6
Start Levee Mile	0.00
End Levee Mile	0.00
Location	
Category	Channels
Item	Vegetation & Obstructions
Bear Creek downstream of Bonner Rd.	
phillips_c_20100913_121.jpg

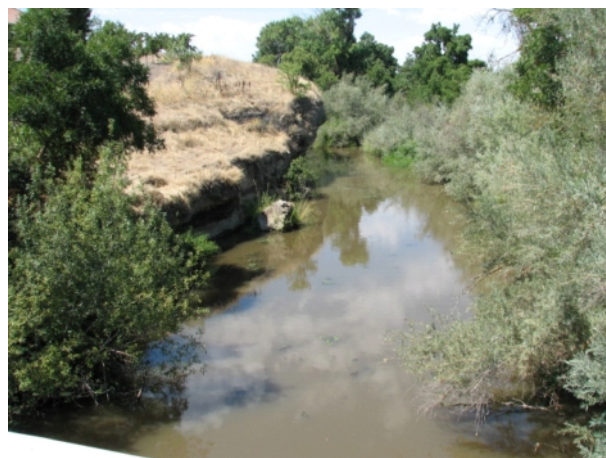
Levee Mile Report Line	11
Start Levee Mile	0.00
End Levee Mile	0.00
Location	
Category	Channels
Item	Vegetation & Obstructions
Bear Creek at Burns Creek confluence. Photo upstream of bridge.	
phillips_c_20100730_003.jpg

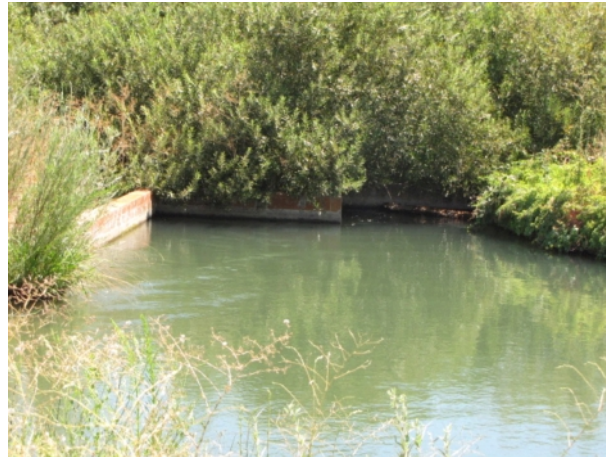
Levee Mile Report Line	15
Start Levee Mile	0.00
End Levee Mile	0.00
Location	
Category	Channels
Item	Encroachments
Confluence of the Burns Creek.	
phillips_c_20100913_122.jpg

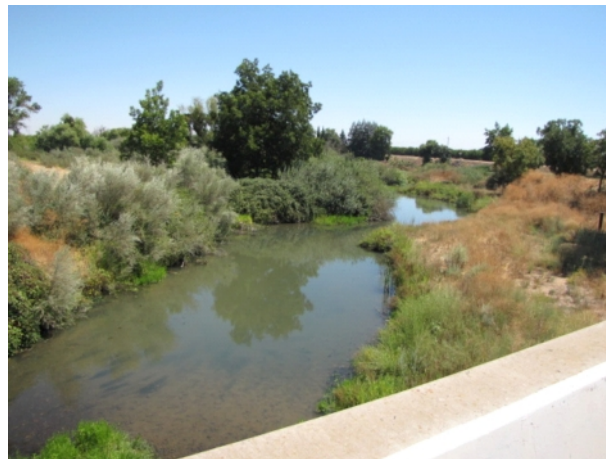
Levee Mile Report Line	21
Start Levee Mile	0.00
End Levee Mile	0.00
Location	
Category	Channels
Item	Vegetation & Obstructions
Bear Creek upstream of Arboleda Rd.	
phillips_c_20100914_124.jpg

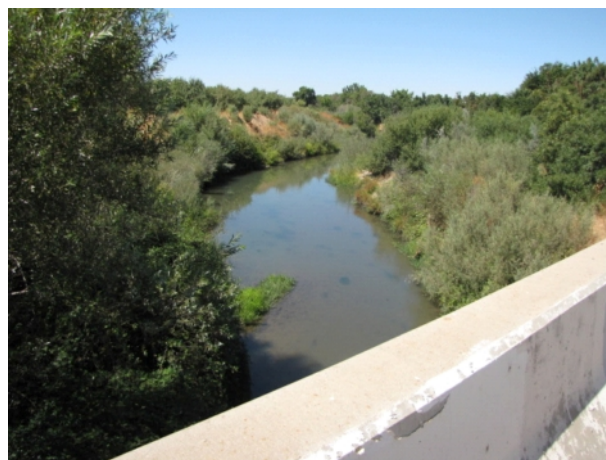
Levee Mile Report Line	26
Start Levee Mile	0.00
End Levee Mile	0.00
Location	
Category	Channels
Item	Vegetation & Obstructions
Bear Creek downstream of Arboleda Rd.	
phillips_c_20100914_125.jpg

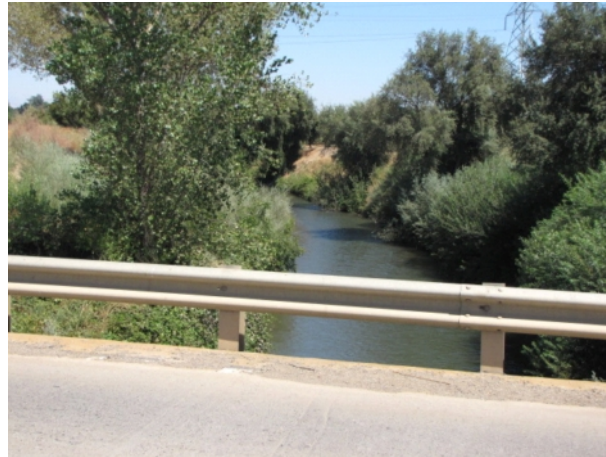
Levee Mile Report Line	31
Start Levee Mile	0.00
End Levee Mile	0.00
Location	
Category	Channels
Item	Vegetation & Obstructions

Bear Creek upstream of Kibby Rd.

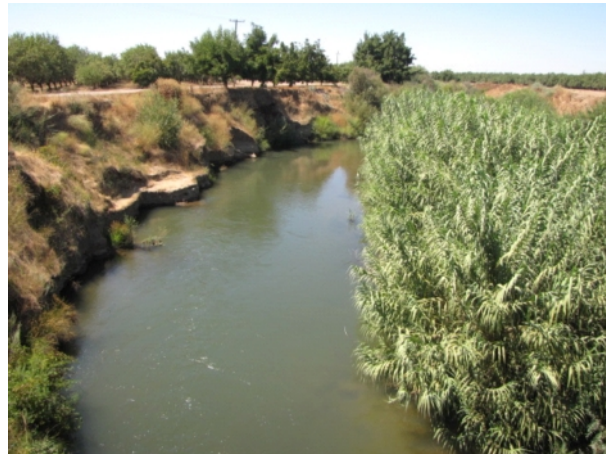
Levee Mile Report Line	36
Start Levee Mile	0.00
End Levee Mile	0.00
Location	
Category	Channels
Item	Vegetation & Obstructions

Bear Creek downstream of Kibby Rd.

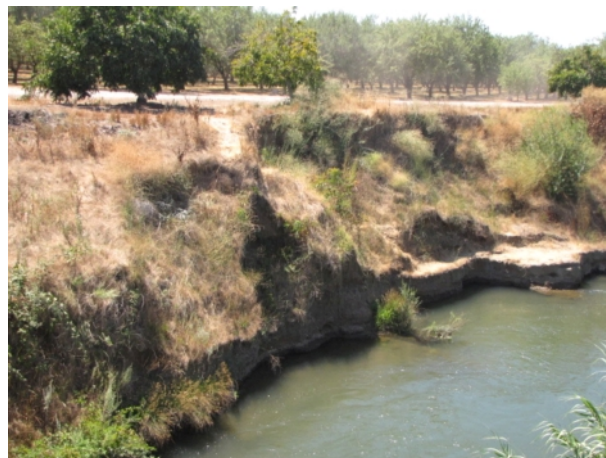
Levee Mile Report Line	38
Start Levee Mile	0.00
End Levee Mile	0.00
Location	
Category	Channels
Item	Erosion / Bank Caving

Left bank erosion more movement since last spring inspection. 37.31192-120.41510 to 37.31269-120.41674.

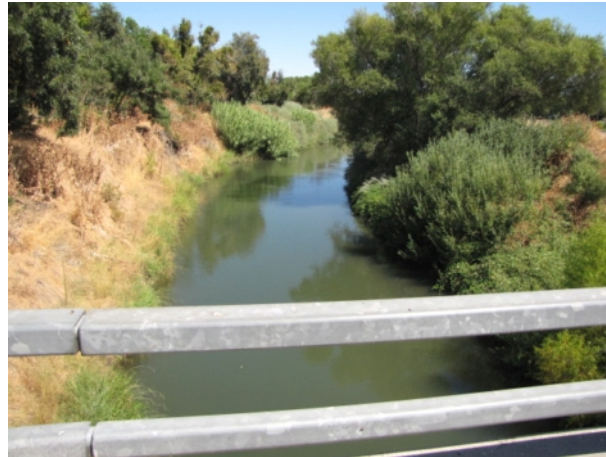
Levee Mile Report Line	41
Start Levee Mile	0.00
End Levee Mile	0.00
Location	
Category	Channels
Item	Vegetation & Obstructions
Bear Creek upstream of McKee Rd.	
phillips_c_20100914_129.jpg

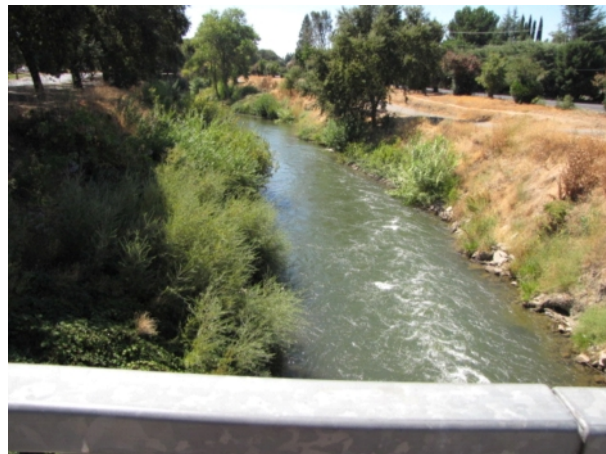
Levee Mile Report Line	46
Start Levee Mile	0.00
End Levee Mile	0.00
Location	
Category	Channels
Item	Vegetation & Obstructions
Bear Creek downstream of McKee Rd.	
phillips_c_20100914_130.jpg

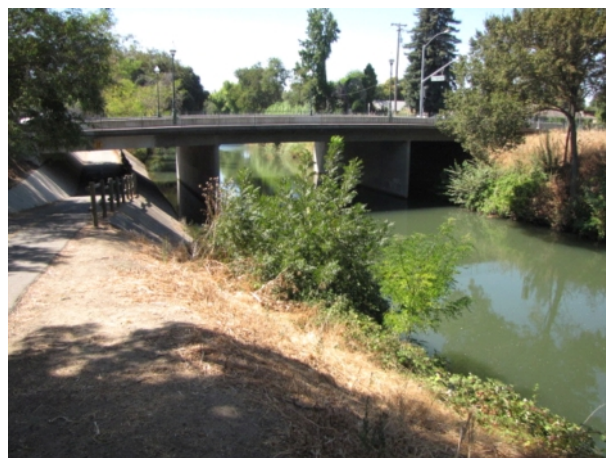
Levee Mile Report Line	51
Start Levee Mile	0.00
End Levee Mile	0.00
Location	
Category	Channels
Item	Vegetation & Obstructions
Standing on the downstream side of R. Street looking upstream under bridge crossing.	
phillips_c_20100914_131.jpg

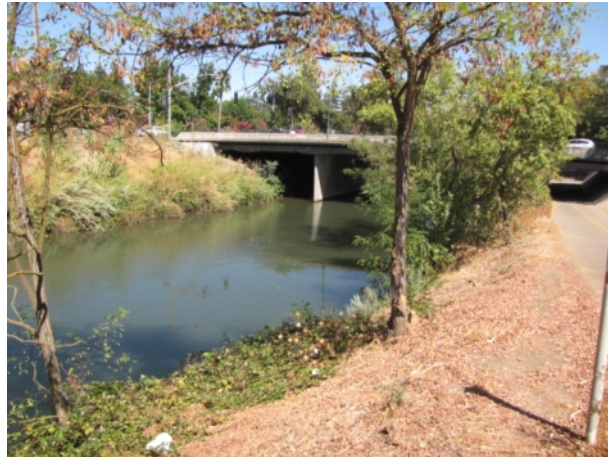
Levee Mile Report Line	56
Start Levee Mile	0.00
End Levee Mile	0.00
Location	
Category	Channels
Item	Vegetation & Obstructions
Upstream of Bear Creek looking downstream at R Street bridge.	
phillips_c_20100914_132.jpg

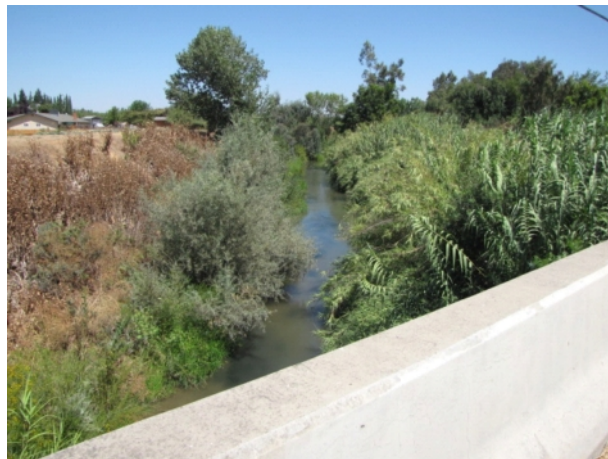
Levee Mile Report Line	71
Start Levee Mile	0.00
End Levee Mile	0.00
Location	
Category	Channels
Item	Vegetation & Obstructions
Bear Creek upstream of Hwy 140.	
phillips_c_20100914_135.jpg

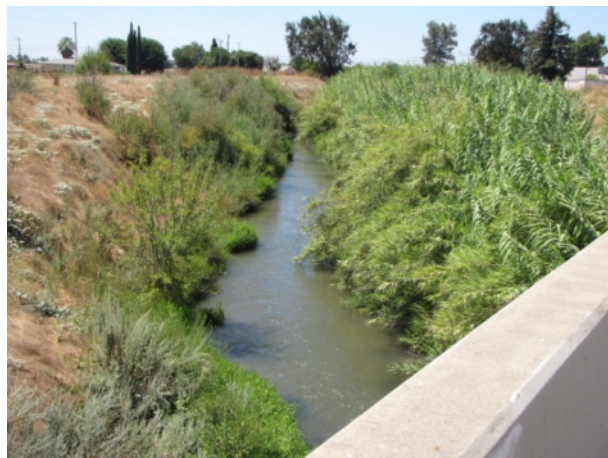
Levee Mile Report Line	76
Start Levee Mile	0.00
End Levee Mile	0.00
Location	
Category	Channels
Item	Vegetation & Obstructions
Bear Creek downstream of Hwy 140.	
phillips_c_20100914_136.jpg

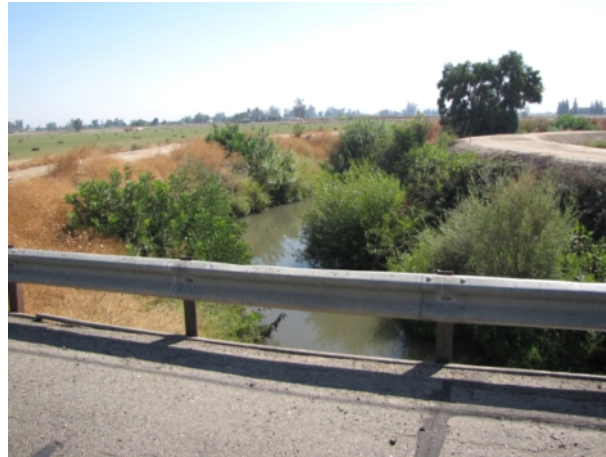
Levee Mile Report Line	81
Start Levee Mile	0.00
End Levee Mile	0.00
Location	
Category	Channels
Item	Vegetation & Obstructions
Bear Creek upstream of Buhach Rd.	
phillips_c_20100914_137.jpg

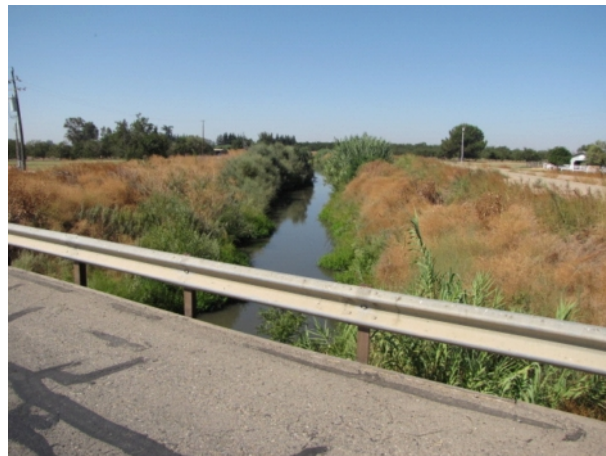
Levee Mile Report Line	86
Start Levee Mile	0.00
End Levee Mile	0.00
Location	
Category	Channels
Item	Vegetation & Obstructions
Bear Creek downstream of Buhach Rd.	
phillips_c_20100914_138.jpg

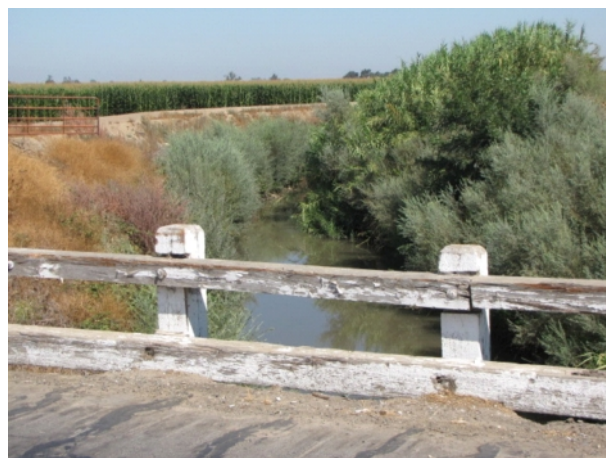
Levee Mile Report Line	91
Start Levee Mile	0.00
End Levee Mile	0.00
Location	
Category	Channels
Item	Vegetation & Obstructions
Bear Creek upstream of Dickerson Ferry Rd.	
phillips_c_20100914_139.jpg

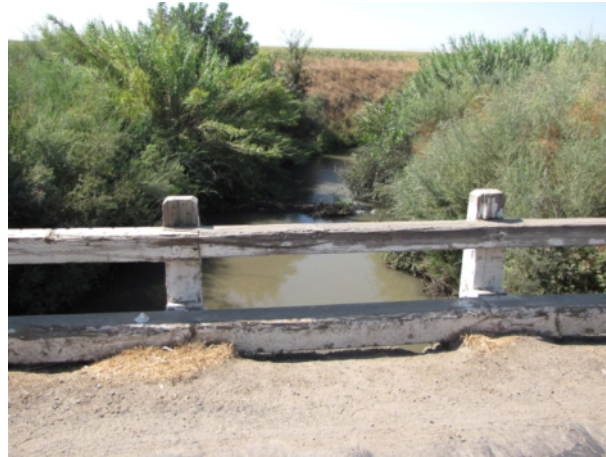
Levee Mile Report Line	96
Start Levee Mile	0.00
End Levee Mile	0.00
Location	
Category	Channels
Item	Vegetation & Obstructions
Bear Creek downstream of Dickerson Rd.	
phillips_c_20100914_140.jpg

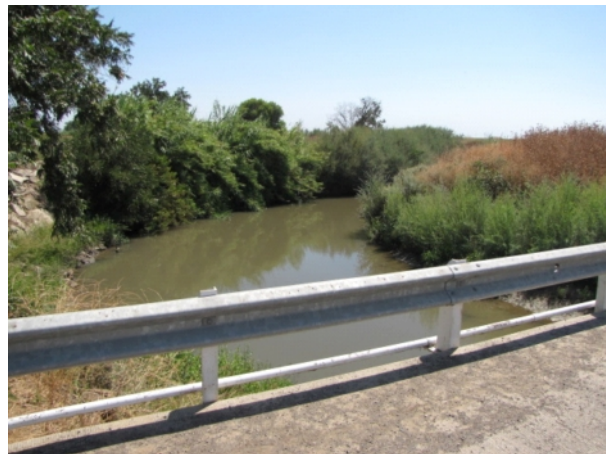
Levee Mile Report Line	101
Start Levee Mile	0.00
End Levee Mile	0.00
Location	
Category	Channels
Item	Vegetation & Obstructions
Downstream limit of Bear Creek looking upstream.	
phillips_c_20100914_141.jpg

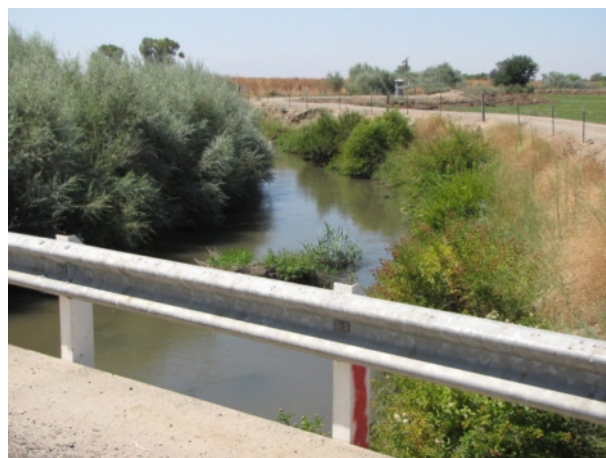
Levee Mile Report Line	106
Start Levee Mile	0.00
End Levee Mile	0.00
Location	
Category	Channels
Item	Vegetation & Obstructions
Bear Creek Downstream of Bert Crane Rd.	
phillips_c_20100914_142.jpg

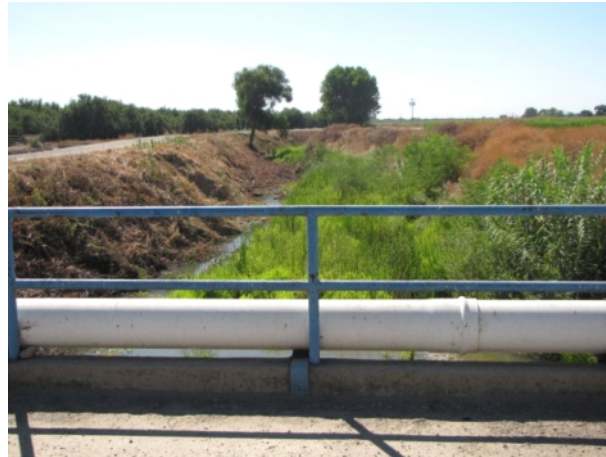
Levee Mile Report Line	16
Start Levee Mile	0.00
End Levee Mile	0.00
Location	
Category	Channels
Item	Vegetation & Obstructions
Black Rascal Creek downstream of Croker Dam.	
phillips_c_20100913_118.jpg

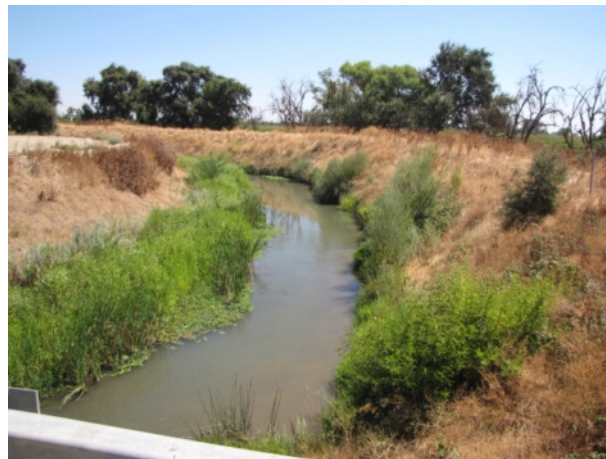
Levee Mile Report Line	21
Start Levee Mile	0.00
End Levee Mile	0.00
Location	
Category	Channels
Item	Vegetation & Obstructions
Black Rascal Creek Upstream of Franklin Rd..	
phillips_c_20100920_150.jpg

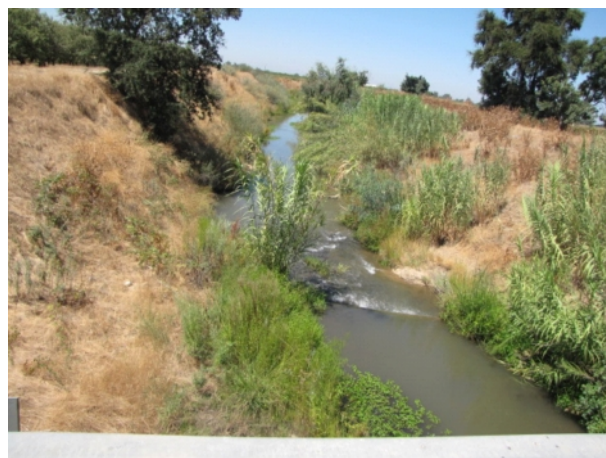
Levee Mile Report Line	26
Start Levee Mile	0.00
End Levee Mile	0.00
Location	
Category	Channels
Item	Vegetation & Obstructions
Black Rascal Creek downstream of Franklin Rd.	
phillips_c_20100920_151.jpg

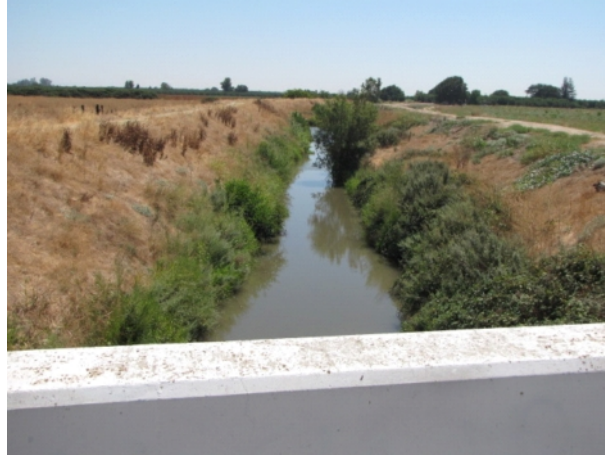
Levee Mile Report Line	31
Start Levee Mile	0.00
End Levee Mile	0.00
Location	
Category	Channels
Item	Vegetation & Obstructions
Black Rascal Creek upstream of Gurr Road.	
phillips_c_20100920_152.jpg

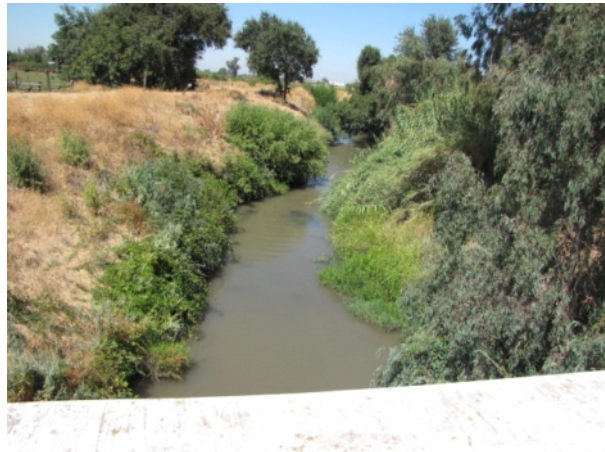
Levee Mile Report Line	36
Start Levee Mile	0.00
End Levee Mile	0.00
Location	
Category	Channels
Item	Vegetation & Obstructions
Black Rascal Creek downstream of Gurr Road.	
phillips_c_20100920_153.jpg

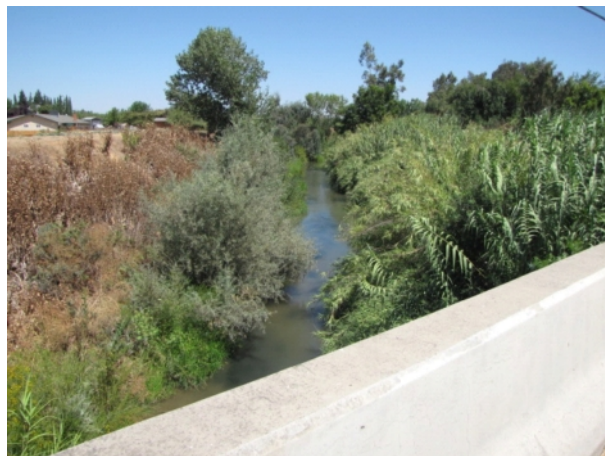
Levee Mile Report Line	41
Start Levee Mile	0.00
End Levee Mile	0.00
Location	
Category	Channels
Item	Vegetation & Obstructions
Black Rascal Creek upstream of Hwy 140	
phillips_c_20100920_154.jpg

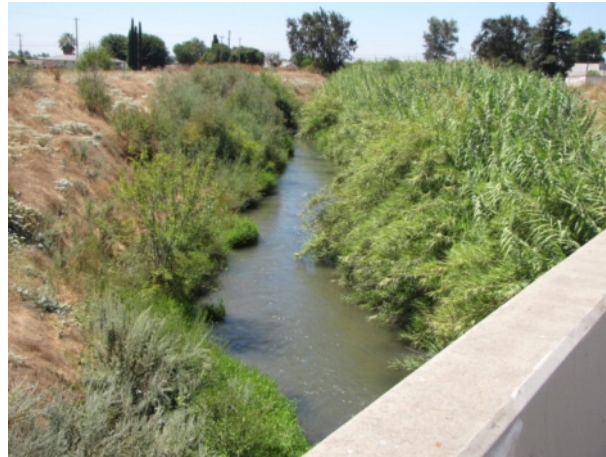
Levee Mile Report Line	46
Start Levee Mile	0.00
End Levee Mile	0.00
Location	
Category	Channels
Item	Vegetation & Obstructions
Black Rascal Creek downstream of Hwy 140.	
phillips_c_20100920_155.jpg

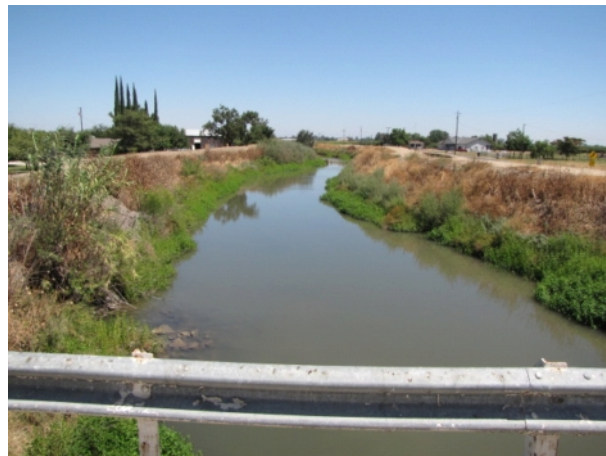
Levee Mile Report Line	51
Start Levee Mile	0.00
End Levee Mile	0.00
Location	
Category	Channels
Item	Vegetation & Obstructions
Black Rascal Creek upstream of Quinley.	
phillips_c_20100913_114.jpg

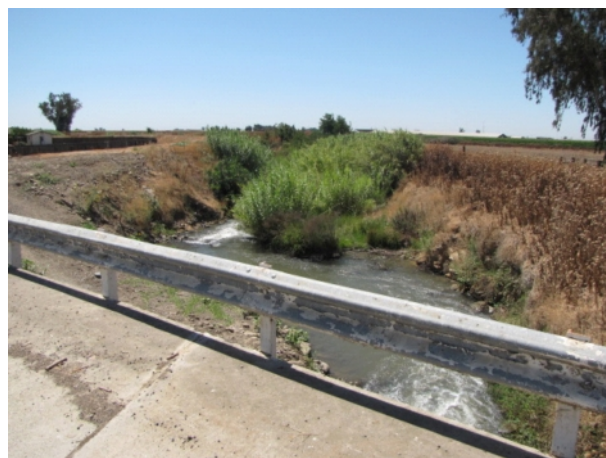
Levee Mile Report Line	56
Start Levee Mile	0.00
End Levee Mile	0.00
Location	
Category	Channels
Item	Vegetation & Obstructions
Black Rascal Creek downstream of Quinley.	
phillips_c_20100913_115.jpg

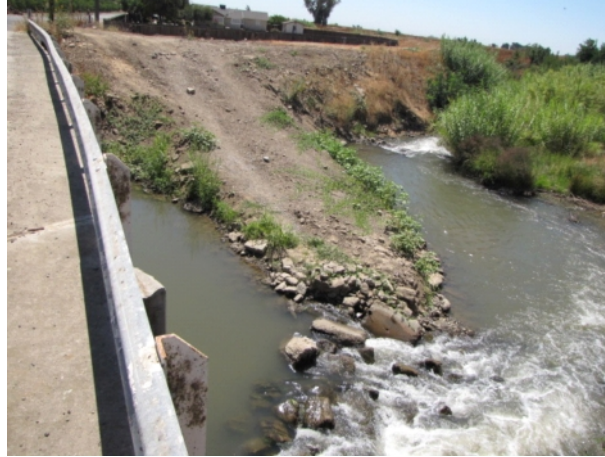
Levee Mile Report Line	60
Start Levee Mile	0.00
End Levee Mile	0.00
Location	
Category	Channels
Item	Encroachments
Black Rascal Creek downstream of Quinley Road Ave.	
phillips_c_20100913_117.jpg

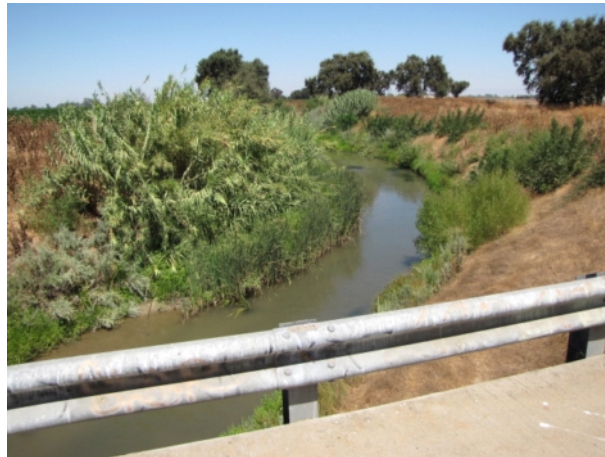
Levee Mile Report Line	61
Start Levee Mile	0.00
End Levee Mile	0.00
Location	
Category	Channels
Item	Vegetation & Obstructions
Black Rascal Creek upstream of Oak Ave.	
phillips_c_20100920_156.jpg

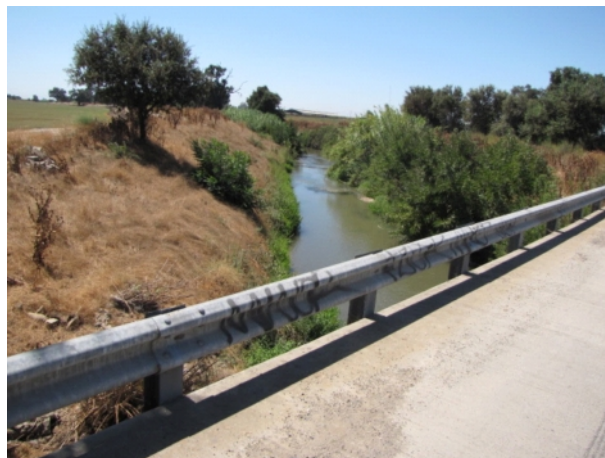
Levee Mile Report Line	66
Start Levee Mile	0.00
End Levee Mile	0.00
Location	
Category	Channels
Item	Vegetation & Obstructions
Black Rascal Creek downstream of Oak Ave.	
phillips_c_20100920_157.jpg

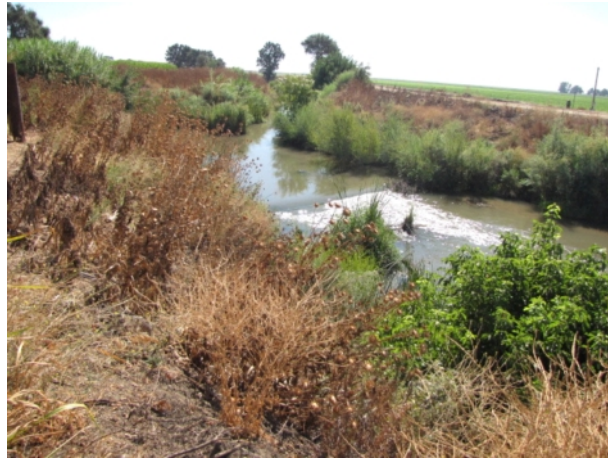
Levee Mile Report Line	71
Start Levee Mile	0.00
End Levee Mile	0.00
Location	
Category	Channels
Item	Vegetation & Obstructions
Standing downstream of the Confluence of Black Rascal and the Bear Creek.looking upstream.	
phillips_c_20100920_158.jpg

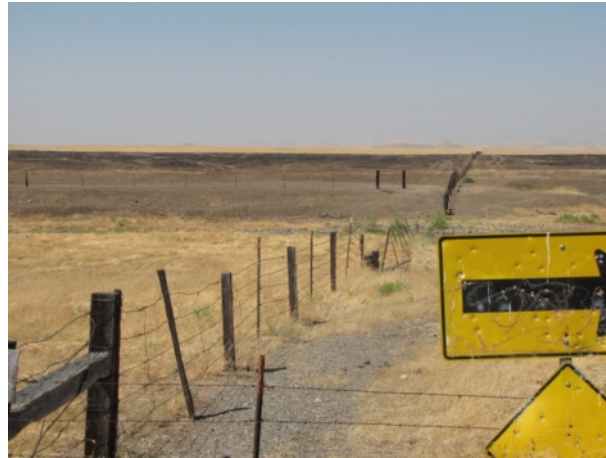
Levee Mile Report Line	1
Start Levee Mile	0.00
End Levee Mile	0.00
Location	
Category	Channels
Item	Vegetation & Obstructions
Mariposa Creek upstream at White Rock. Channel is dry. 37.261425N -120.198078W	
phillips_c_20100903_093.jpg

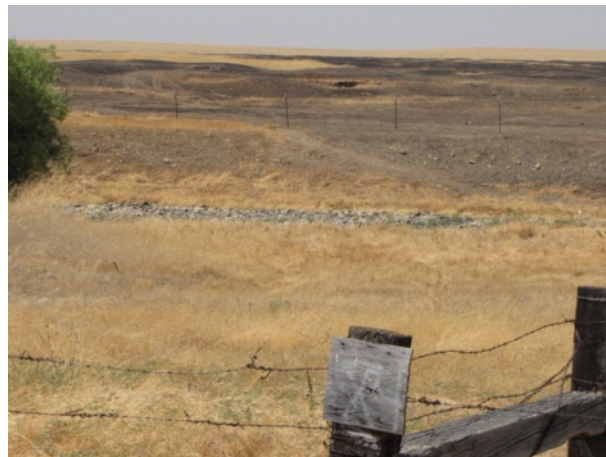
Levee Mile Report Line	6
Start Levee Mile	0.00
End Levee Mile	0.00
Location	
Category	Channels
Item	Vegetation & Obstructions
Mariposa Creek downstream at White Rock Road.	
phillips_c_20100903_094.jpg

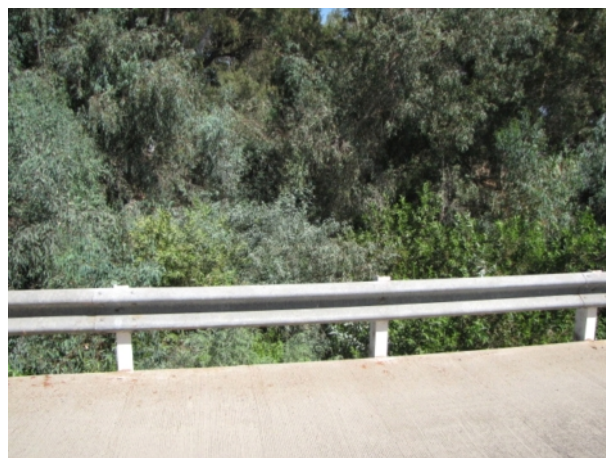
Levee Mile Report Line	11
Start Levee Mile	0.00
End Levee Mile	0.00
Location	
Category	Channels
Item	Vegetation & Obstructions
Mariposa Creek upstream of Fresno Road. 37.23803N -120.24352W.	
phillips_c_20100903_095.jpg

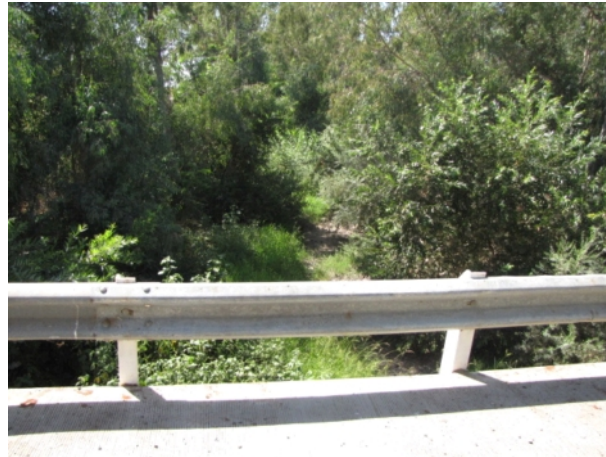
Levee Mile Report Line	16
Start Levee Mile	0.00
End Levee Mile	0.00
Location	
Category	Channels
Item	Vegetation & Obstructions
Mariposa Creek downstream of Fresno Road	
phillips_c_20100903_096.jpg

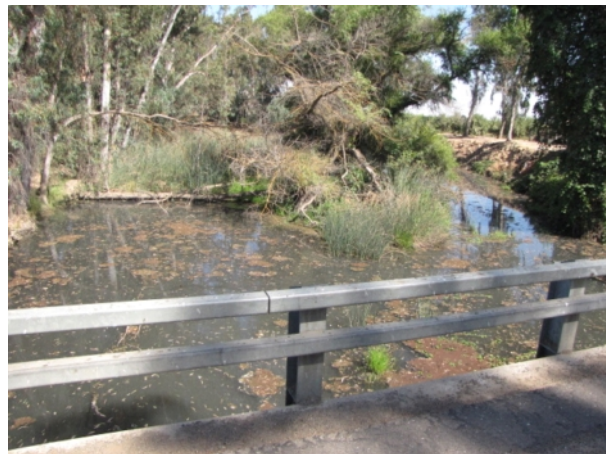
Levee Mile Report Line	21
Start Levee Mile	0.00
End Levee Mile	0.00
Location	
Category	Channels
Item	Vegetation & Obstructions
Mariposa Creek Upstream of Cunningham Road.	
phillips_c_20100903_097.jpg

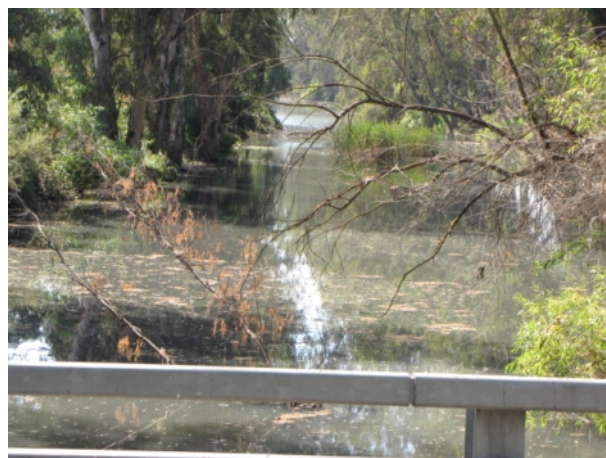
Levee Mile Report Line	26
Start Levee Mile	0.00
End Levee Mile	0.00
Location	
Category	Channels
Item	Vegetation & Obstructions
Mariposa Creek downstream of Cunningham Road.	
phillips_c_20100903_098.jpg

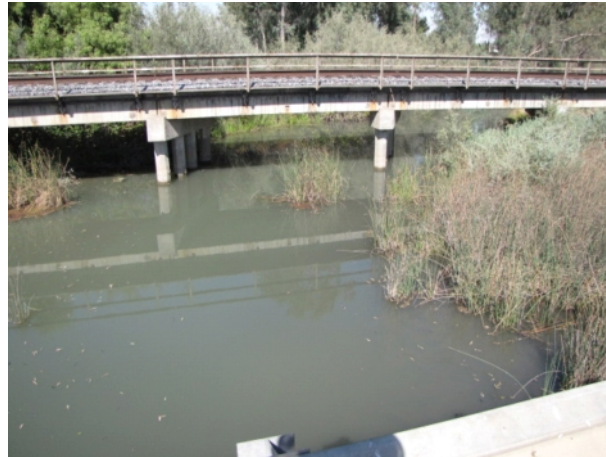
Levee Mile Report Line	31
Start Levee Mile	0.00
End Levee Mile	0.00
Location	
Category	Channels
Item	Vegetation & Obstructions
Upstream of Slough at Santa Fe Road. 37.23922N -120.25902W.	
phillips_c_20100903_099.jpg

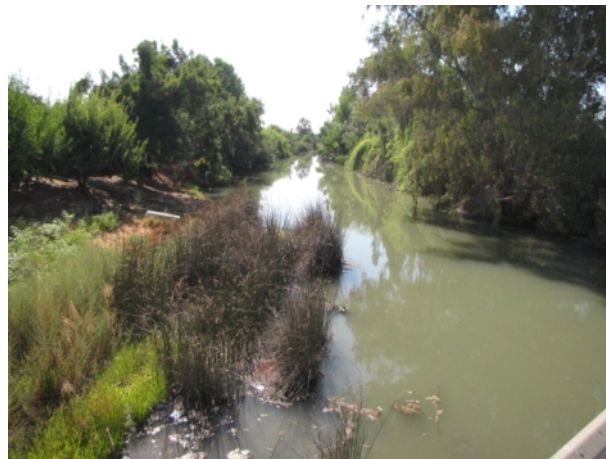
Levee Mile Report Line	36
Start Levee Mile	0.00
End Levee Mile	0.00
Location	
Category	Channels
Item	Vegetation & Obstructions
Duck slough downstream of Santa Fe Road.	
phillips_c_20100903_100.jpg

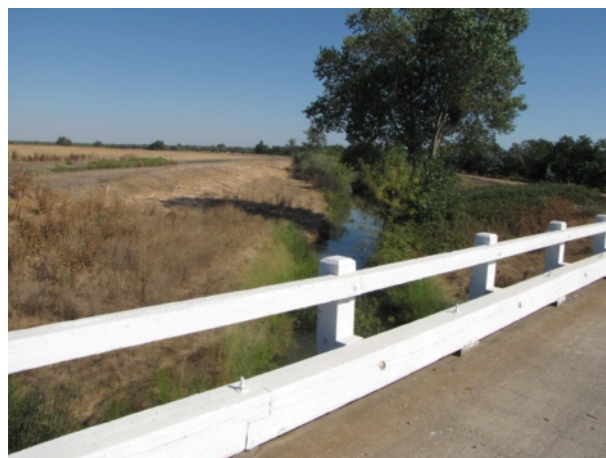
Levee Mile Report Line	41
Start Levee Mile	0.00
End Levee Mile	0.00
Location	
Category	Channels
Item	Vegetation & Obstructions
Duck Slough upstream of Burshell Road.	
phillips_c_20100903_101.jpg

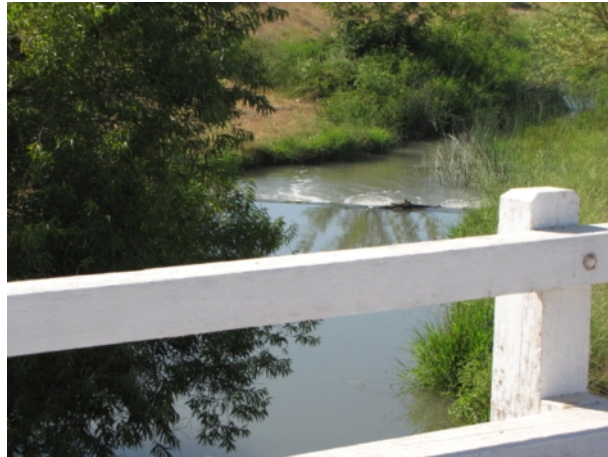
Levee Mile Report Line	46
Start Levee Mile	0.00
End Levee Mile	0.00
Location	
Category	Channels
Item	Vegetation & Obstructions
Downstream of Creek at Burchell Road Bridge.	
phillips_c_20100903_102.jpg

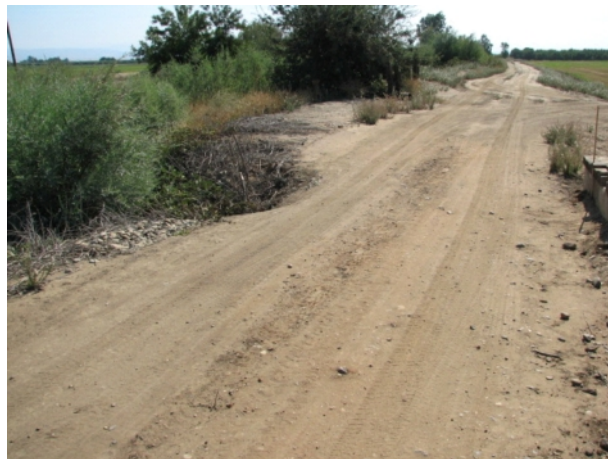
Levee Mile Report Line	48
Start Levee Mile	0.00
End Levee Mile	0.00
Location	
Category	Channels
Item	Erosion / Bank Caving
Erosion on left bank of Duck Slough downstream of Burchell Rd.	
phillips_c_20100730_052.jpg

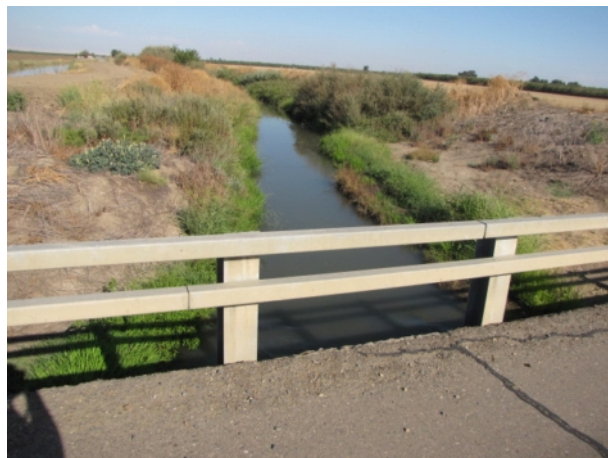
Levee Mile Report Line	51
Start Levee Mile	0.00
End Levee Mile	0.00
Location	
Category	Channels
Item	Vegetation & Obstructions
Duck Slough upstream of Plainsburg Rd.	
phillips_c_20100903_103.jpg

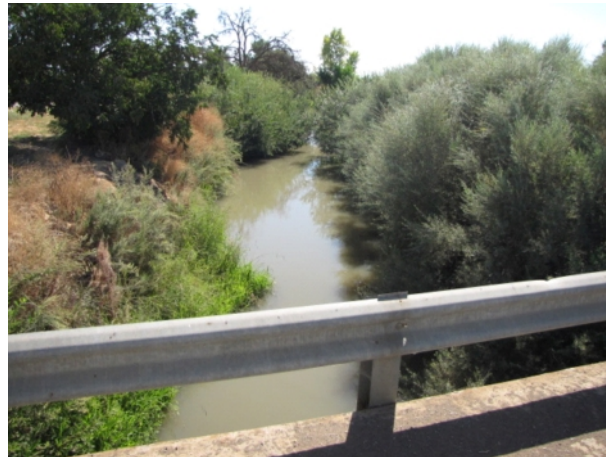
Levee Mile Report Line	61
Start Levee Mile	0.00
End Levee Mile	0.00
Location	
Category	Channels
Item	Vegetation & Obstructions

Duck Slough upstream of Whealan Rd.

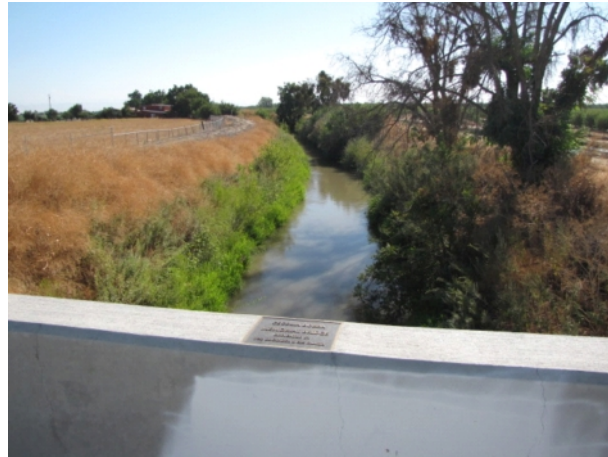
Levee Mile Report Line	71
Start Levee Mile	0.00
End Levee Mile	0.00
Location	
Category	Channels
Item	Vegetation & Obstructions
Duck Slough upstream of Arboledo Rd. 37.257036N -120.379219W	
phillips_c_20100908_106.jpg

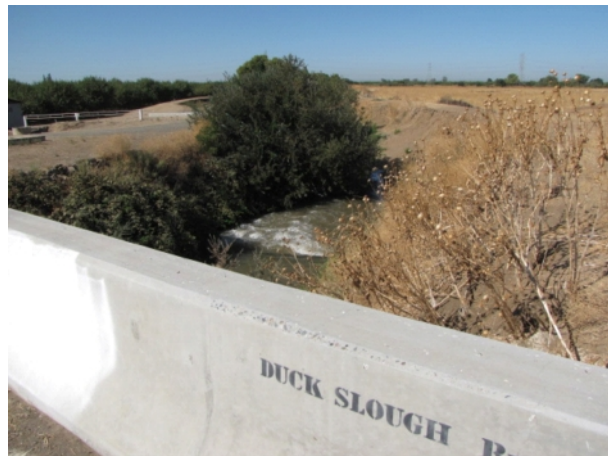
Levee Mile Report Line	76
Start Levee Mile	0.00
End Levee Mile	0.00
Location	
Category	Channels
Item	Vegetation & Obstructions
Duck Slough downstream of Arboleda Rd.	
phillips_c_20100908_107.jpg

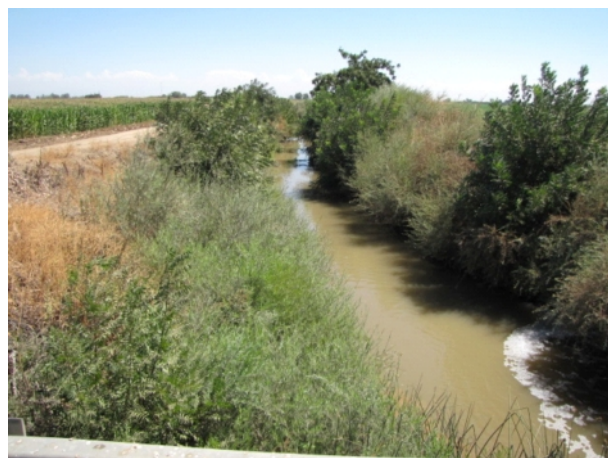
Levee Mile Report Line	81
Start Levee Mile	0.00
End Levee Mile	0.00
Location	
Category	Channels
Item	Vegetation & Obstructions
Duck Slough upstream of Healy Rd.	
phillips_c_20100908_110.jpg
